## EXISTING CONDITIONS SUMMARY

### Bethany Boulevard Corridor Operations

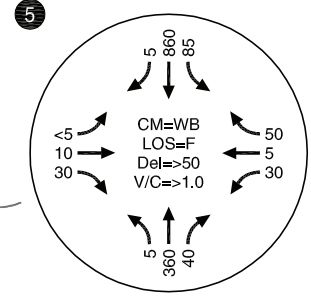
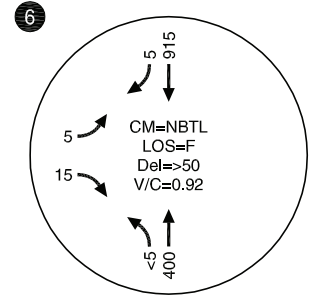
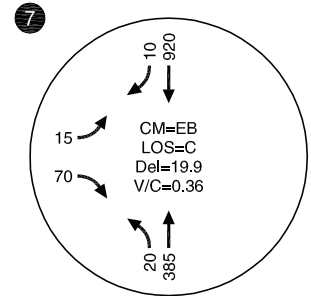
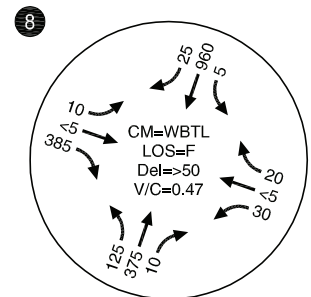
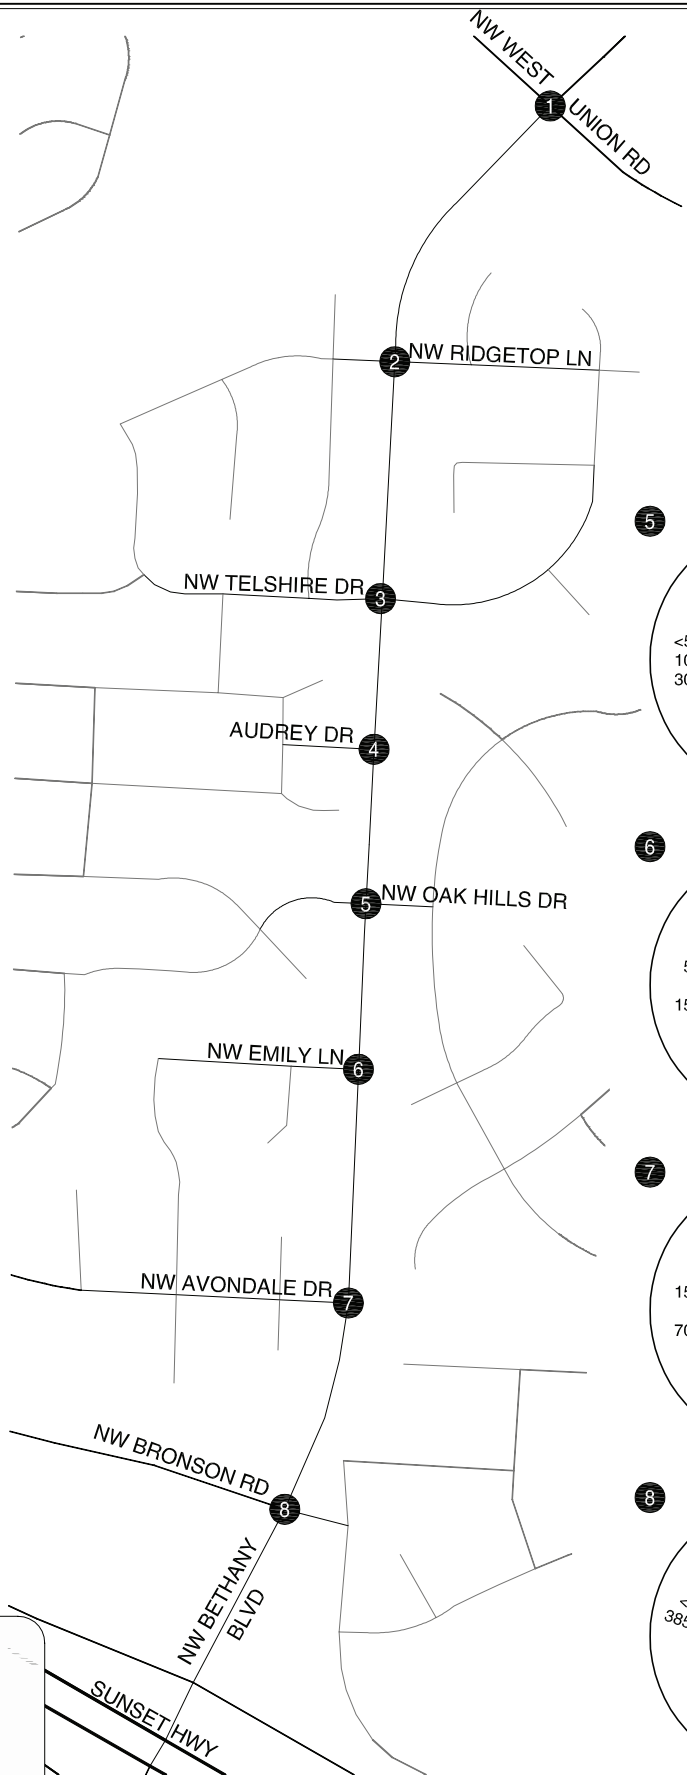
- CM = CRITICAL MOVEMENT (UNSIGNALIZED)
- LOS = INTERSECTION LEVEL OF SERVICE (SIGNALIZED)/CRITICAL MOVEMENT LEVEL OF SERVICE (UNSIGNALIZED)
- Del = INTERSECTION AVERAGE CONTROL DELAY (SIGNALIZED)/CRITICAL MOVEMENT CONTROL DELAY (UNSIGNALIZED)
- V/C = CRITICAL VOLUME-TO-CAPACITY RATIO

- Existing turning movement volumes at the study intersections are shown in Figures 1 and 2 for the weekday a.m. and p.m. peak hours, respectively. The following table summarizes the key traffic statistics.
